**DEPARTMENT OF TRANSPORTATION**

Contract #: 04-0120F4Cty: SF/ALA Rte: 80 PM: 13.2/13.9File #: 69.28**WELDING INSPECTION REPORT****Resident Engineer:**Pursell, Gary**Address:** 333 Burma Road**City:** Oakland, CA 94607**Report No:** WIR-015504**Date Inspected:** 10-Jul-2010**Project Name:** SAS Superstructure**OSM Arrival Time:** 700**Prime Contractor:** American Bridge/Fluor Enterprises, a JV**OSM Departure Time:** 1900**Contractor:** Zhenhua Port Machinery Company, Ltd (ZPMC), Changxing Island **Location:** Shanghai, China**CWI Name:** Li Yang**CWI Present:** Yes No**Inspected CWI report:** Yes No N/A**Rod Oven in Use:** Yes No N/A**Electrode to specification:** Yes No N/A**Weld Procedures Followed:** Yes No N/A**Qualified Welders:** Yes No N/A**Verified Joint Fit-up:** Yes No N/A**Approved Drawings:** Yes No N/A**Approved WPS:** Yes No N/A**Delayed / Cancelled:** Yes No N/A**Bridge No:** 34-0006**Component:** OBG Segment**Summary of Items Observed:**

**OBG # TRIAL ASSEMBLY YARD**

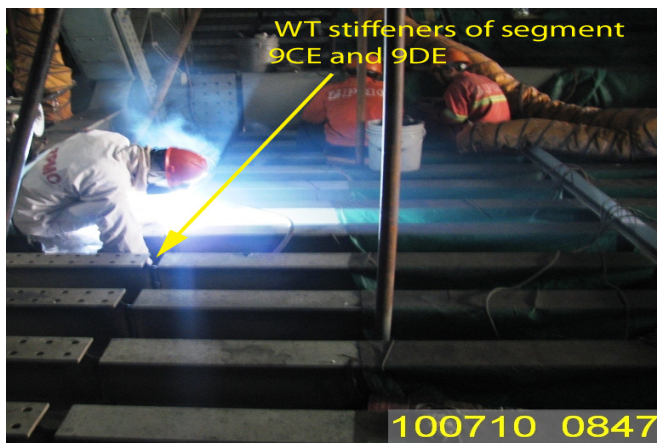
For additional information please reference the pictures below:

### OBG # TRIAL ASSEMBLY YARD (9AW-9BW)

The QA inspector observed the welding operation per the SMAW process on weld joint no. 003 in the (4G) vertical position on bottom panel piece mark no. OBW9B. The location was the transverse splice weld joining segment 9BE and 9CE. The welder ID was 220069. The ZPMC CWI was identified as Li Yang. The welding was performed against critical welding repair report B-CWR1698. The welding variables recorded by QC appeared to comply with the WPS-345-SMAW-4G (4F)-FCM-Repair-1.
